Evolution of a debris-rock slide causing a natural dam: the flash flood of Río Santa Cruz, Province of San Juan—November 12, 2005

Laura P. Perucca · M. Yanina Esper Angillieri

Abstract Between 2001 and 2005, a large debris rock slide occurred on the western slope of the Cordillera de Santa Cruz in the southeast Andean corner of the Province of San Juan (31°40' S–70°16' W). The landslide material accumulated in a downstream gorge as a natural dam of the Santa Cruz river, forming a large-volume lake. In November 2005, probably as a result of the increasing pressure of the water volume, this natural dam breached off with a violent and unexpected flash flood. In addition to life-threatening instances lived by some people downstream, this flood caused great economic loss to main localities of the Department of Calingasta, as well as considerable damage to one of the most relevant projects of the Province, the Caracoles Hydropower Project dam on the San Juan river. Considering the high costs of any physical remediation for a natural dam located in this high, remote, and inaccessible mountain area with no reliable road access, the main protective measures left to be pondered are the ins

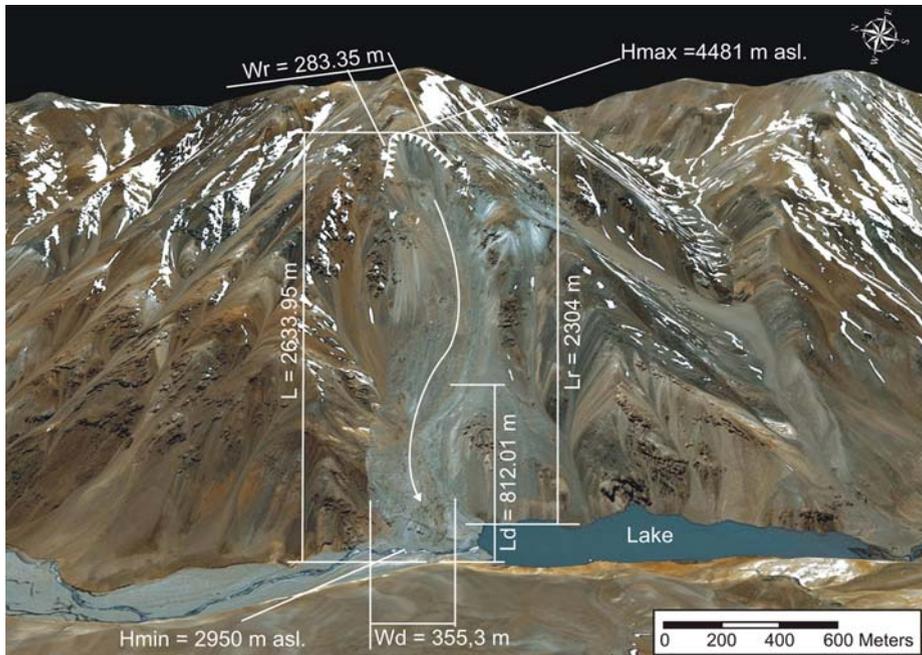
Fig. 3 3D view and geometric analysis of the debris-rock slide in western flank of Cordillera de Santa Cruz

Finally, a digital 3D model of elevations was elaborated that allowed visualizing the actual morphology of the debris-rock slide (Fig. 3).

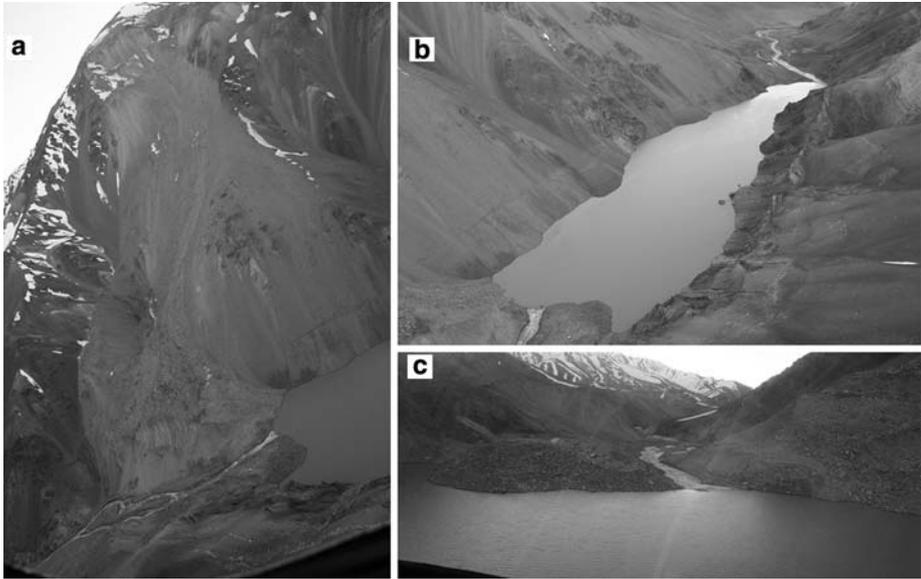
Between years 2001 and 2005, a debris-rock slide took place (Fig. 4a) that occluded the deep valley of Santa Cruz river, originating a natural dam where the river formed a 1.5-km impoundment (Fig. 4b). The debris-rock slide covers an area of about 0.84 km²; the estimated total length of the slide is 2,633 m; and its width is 283 m. This section has a half-circle shape that defines the main scarp; the actual area of the main body deposit covers 0.24 km². The length of the displaced material is 812 m, significantly shorter than the total length of 2,633 m measured from the crown. It has a toe (2,950 m) to crown

Fig. 4 **a** Debris-rock slide in western flank of Cordillera de Santa Cruz, caused blockages in Santa Cruz river. **b** Landslide-dammed lake after the flash flood. **c** Debris-rock slide deposits forming the natural dam, after the collapse (photographs taken in November 2005)

(4,481 m) height of 1,531 m, with a steep slope. These features, along with the large cover of detritus and loose material on the hillsides originated by the periglacial climate of this region, are the conditioning factors for mass wasting phenomena. The deposit covers an area of approximately 0.24 km² with an estimated volume of 12×10^6 m³. This is a poorly supported chaotic deposit conformed mainly by blocks and angular and sub-angular detritus of various sizes, embedded in a fine-grained matrix. Its composition is heterogeneous, presenting volcanic breccias predominantly rhyolites, tuffs, sandstones, and conglomerates (Fig. 4c). In addition to the main scarp, there exist multiple landslide scars that pose potential rupture surfaces, with which the probability of new rock slide occurrences is greatly increased (active mass wasting; Fig. 5). After having analyzed the map of slopes for both margins of Río Santa Cruz, it can be noted that the creek shows an asymmetric profile, with an abrupt eastern side and a much less inclined western hillside. Since the prevailing wind direction is W–NW, the western side of the Cordillera Santa Cruz performs like an orographical barrier that promotes the snow accumulation phenomena on its western side, increasing cryoclastism.

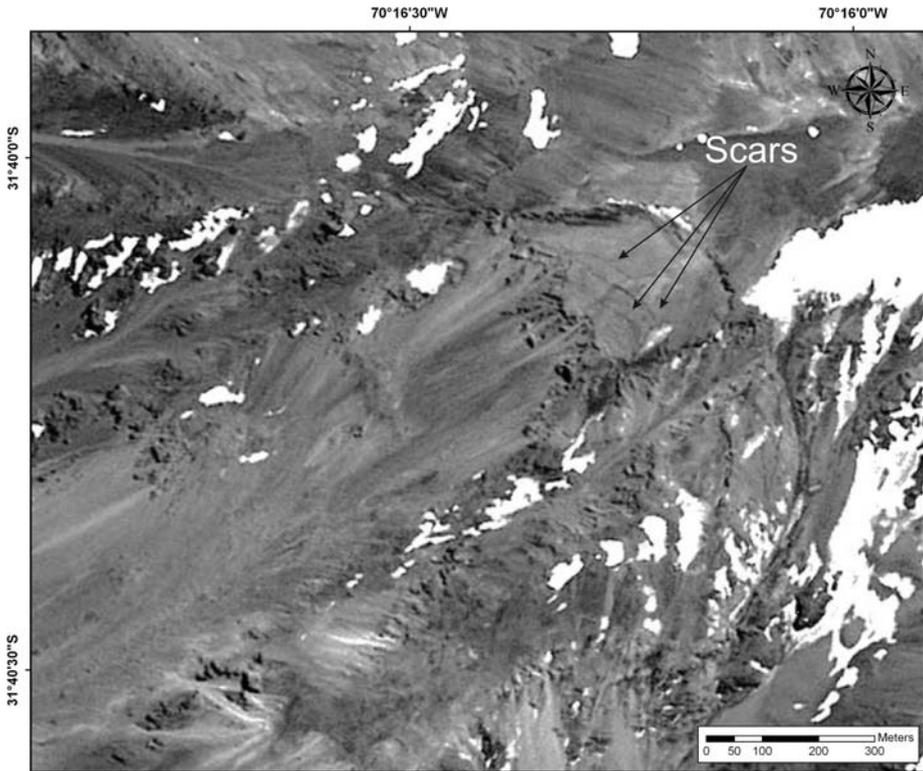
Fig. 5 Active scars on the top of the landslide

In the debris-rock slide sector, the presence of minor scarps points to the instability of the hill slope and to the great probability of new rock and detritus slide occurrences that may close the creek again. On the other hand, the lake formed between years 2001 and 2005 was discharged only in part which means that, at present, it is possible to observe that it still keeps a ponding length longer than 1.5 km and a sizable stored water volume.

On account of the above exposed facts, the study conclusions suggest as necessary a monitoring program of the slopes and hillsides of Santa Cruz river, by means of satellite images and air photography during different seasons of the year, and in consecutive years. This first measure should go along with field surveillance in order to know in detail the evolution of these phenomena and the characteristics of the deposits caused by landslides.

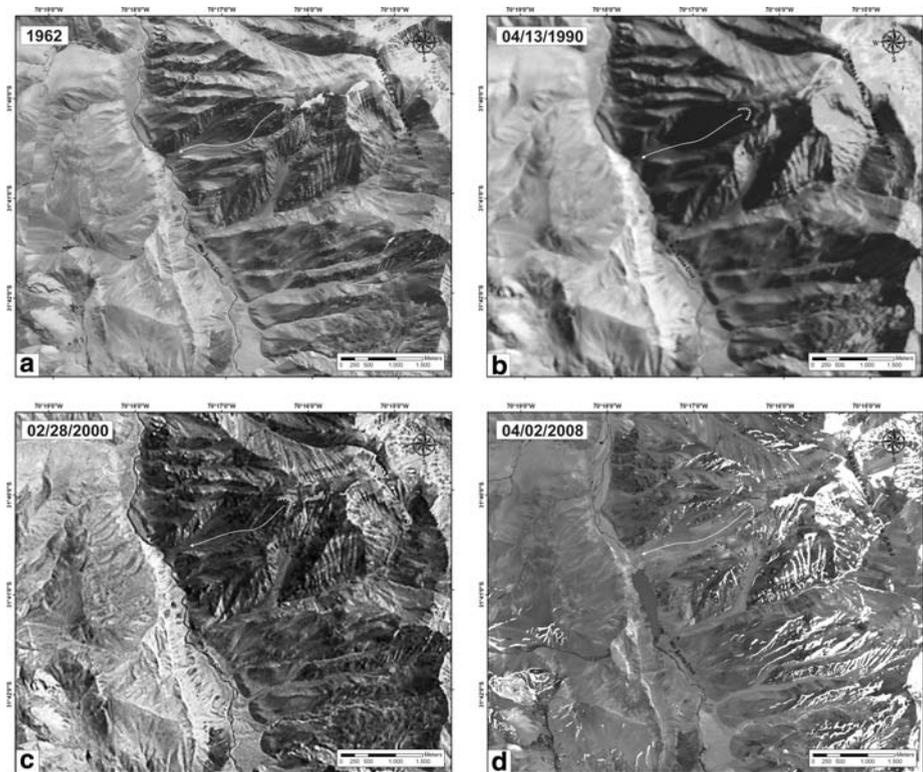
Photographs taken in 1962 show a small landslide eroded at its foot by Rio Santa Cruz. The length of the main scarp is 322.67 m (Fig. 6a). In the LandSat TM image of April 1990, the main scarp has increased its length to 437.98 m, though there is no significant increase in slid material volume (Fig. 6b). In the LandSat ETM+ image of February 28, 2000, the deposit covers a greater area though it does not quite close the creek totally. The length of the main scarp is 562.37 m (Fig. 6c). In the Spot image of April 2008, after the

collapse of the natural dam, it is possible to recognize new zones for probable dam rupture on the crown sector. The length of the main scarp is 709.89 m and the lake remains (Fig. 6d).

Fig. 6 Multitemporary evolution of the landslide by comparing **a** air photos (1962) and satellite images **b** 1990, **c** 2000, and **d** 2008
