Evolution of a debris-rock slide causing a natural dam: the flash flood of Río Santa Cruz, Province of San Juan—November 12, 2005

Laura P. Perucca · M. Yanina Esper Angillieri

Abstract Between 2001 and 2005, a large debris rock slide occurred on the western slope of the Cordillera de Santa Cruz in the southeast Andean corner of the Province of San Juan (31°40' S–70°16' W). The landslide material accumulated in a downstream gorge as a natural dam of the Santa Cruz river, forming a large-volume lake. In November 2005, probably as a result of the increasing pressure of the water volume, this natural dam breached off with a violent and unexpected flash flood. In addition to life-threatening instances lived by some people downstream, this flood caused great economic loss to main localities of the Department of Calingasta, as well as considerable damage to one of the most relevant projects of the Province, the Caracoles Hydropower Project dam on the San Juan river. Considering the high costs of any physical remediation for a natural dam located in this high, remote, and inaccessible mountain area with no reliable road access, the main protective measures left to be pondered are the ins

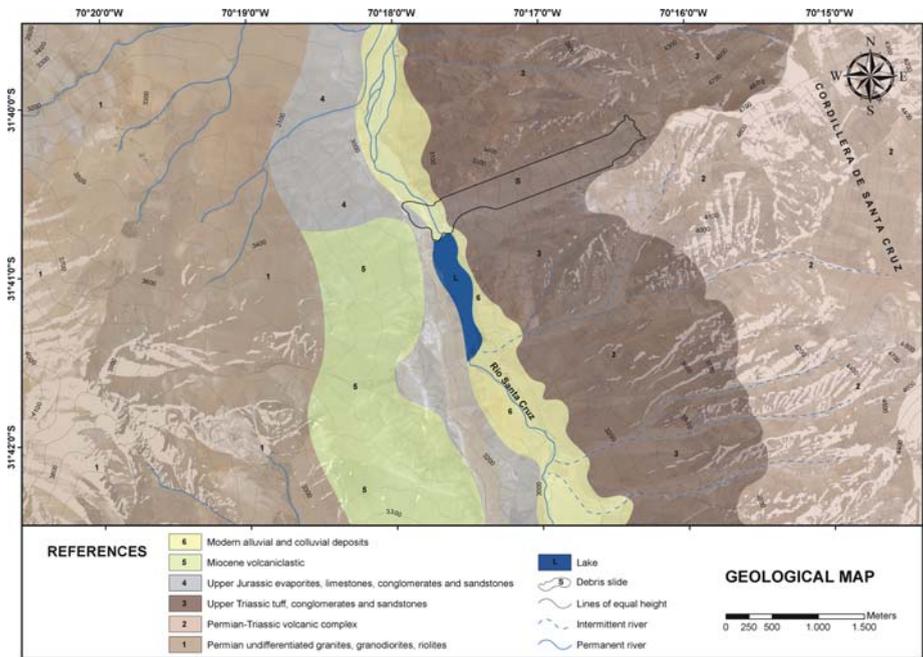
Fig. 2 Lithological map of the Santa Cruz river area

extensional features marked by faults and broken folds affecting the Jurassic and Cretaceous rocks, onto which the Andean tectonics play an important role (Pérez 1995). The Santa Cruz fault (Lencinas 1982) is a reverse fault with western dip affecting the western slope of Cordillera Santa Cruz and a main cause for block-lifting this range. On the western margin of Santa Cruz river, numerous gravitational mass movements took place, mainly rock avalanches, detritic cones, and debris-rock slides. Upstream, in the head waters of the basin, numerous rock glaciers, mainly talus-derived rock glaciers, are found.
